Root Cause Analysis

of
North West Community Campus
Dumfries

For
Scottish Futures Trust

Date : **12/12/2019**

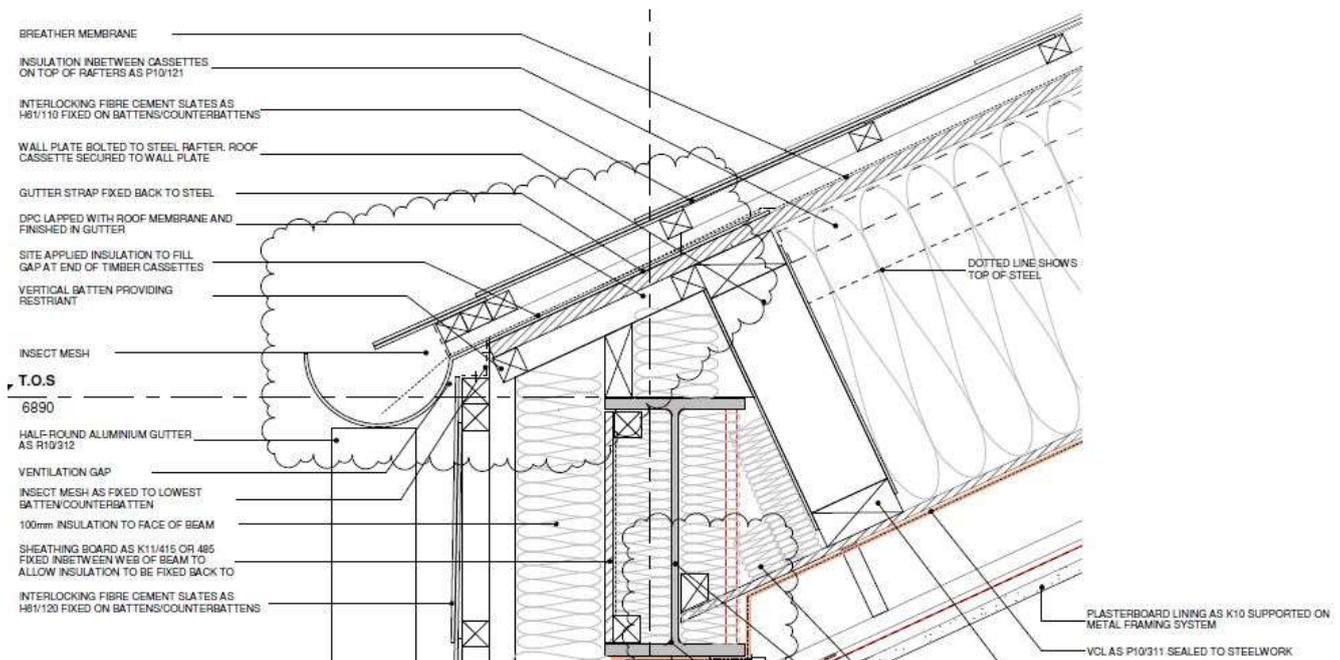
Extract from Holmes Miller drawing 3462 AA(2)100 Rev A issued 31st October 2016 showing roof section.

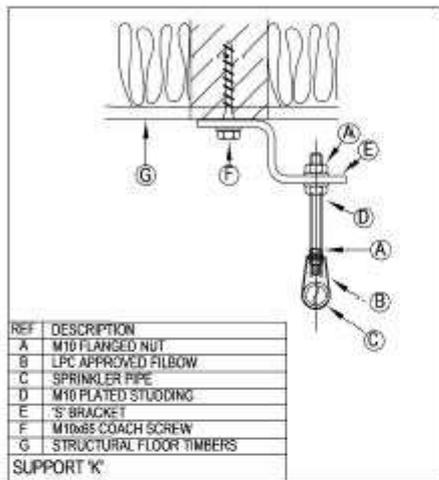
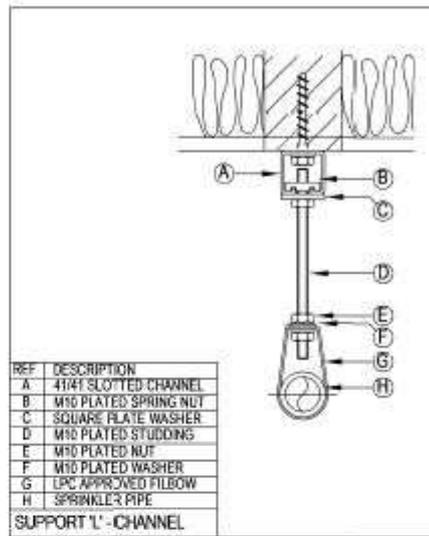
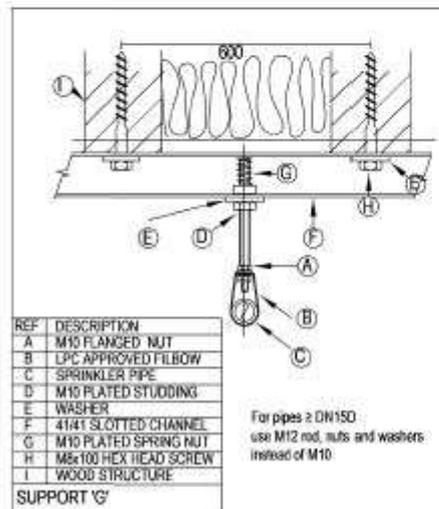
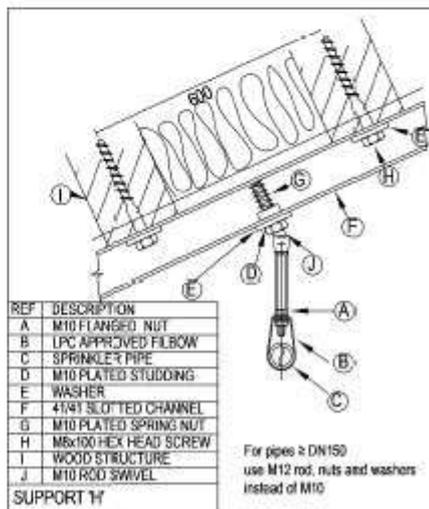
- 6.39. Some builderworks designs by JBE have been made available to us. As noted above, they set out ply pattering above the plasterboard for the fixing of various services installations. These documents are incomplete. We cannot confirm exactly what was presented to the Design Team for review. During several interviews we were assured that all Contractor Designed Portions (CDP) and subcontractor developed design information was reviewed by the Design Team. This begs the question as to how deficient design information was allowed to proceed.

Extract from Compco As Built drawing N6087-01-02 showing Builderworks generic details.

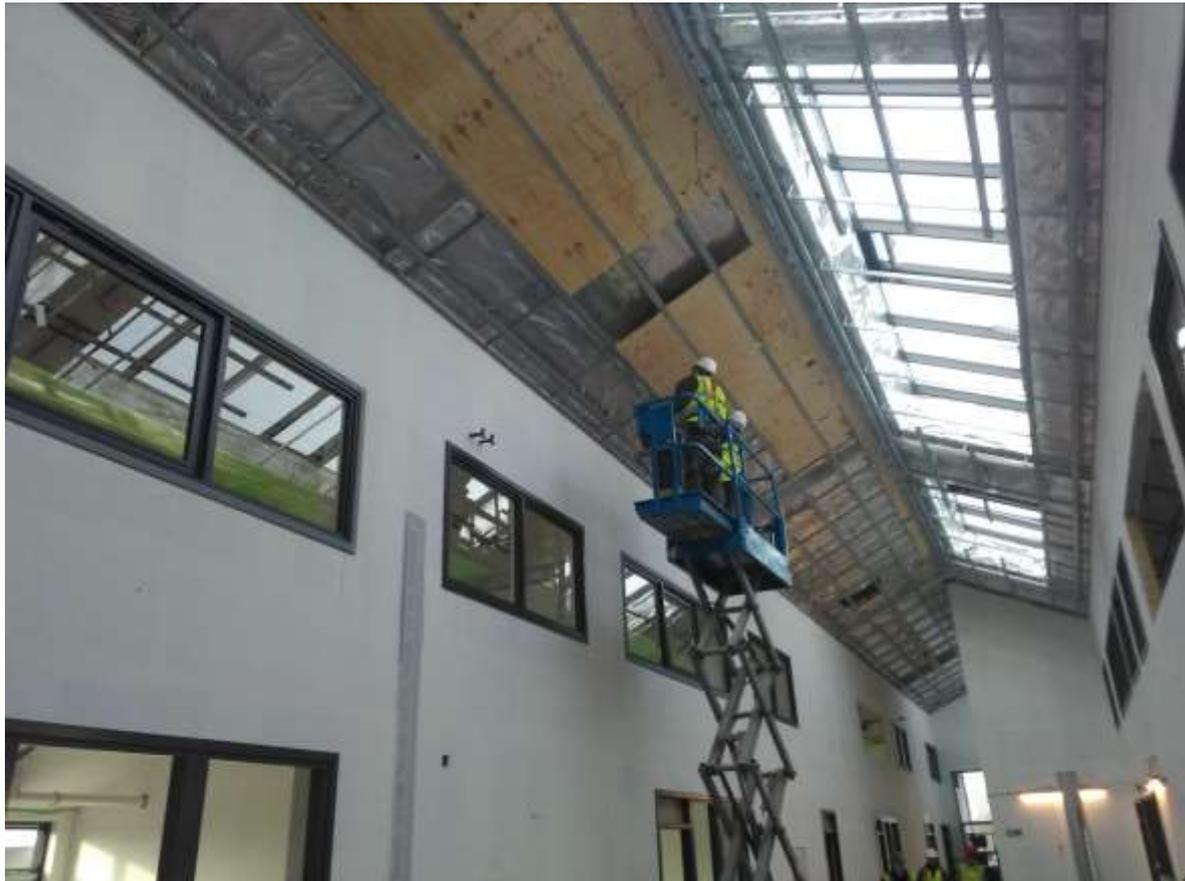
- 6.27. From our review of the documents no explicit, project-specific design was provided to confirm how the services were to connect back to structure when installed on the face of the MF ceiling. As noted above, despite it being a structural element, complicated by the services distribution strategy and the requirement to transfer loads past the MF ceiling system, this was ultimately the responsibility of the M&E subcontractor. A performance specification for the builderworks was provided by the services engineer pre-Financial Close. This provided a baseline for the technical design to be compared against.

Photograph of ceiling install showing underside of cassette, MF ceiling rails and plywood pattrensing.

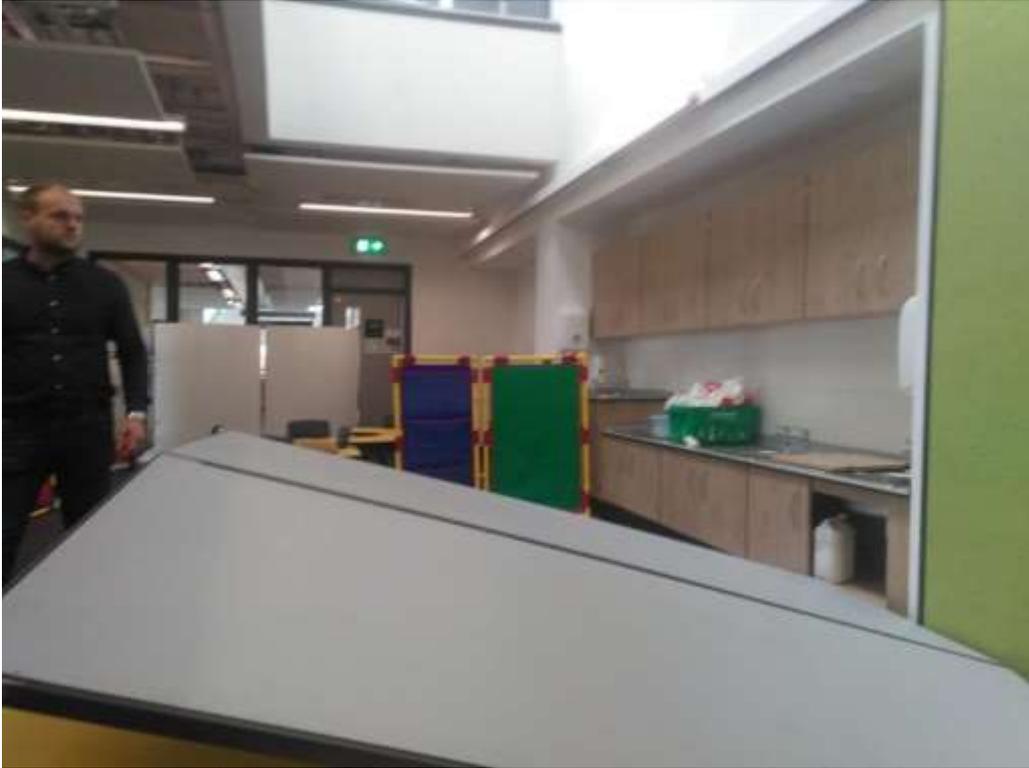
- 7.6. The sliding door arrangement has two doors whose rails overlap slightly in the middle of the opening. There is no jamb at this point, so nothing for the leading edges of the doors to stop against. This leaves the stoppers in the top rails to arrest the movement of what are heavy doors. A reasonable conclusion is that the top stopper was not sufficient to stop the door on its own and so failed.

Photograph following the sliding door failure

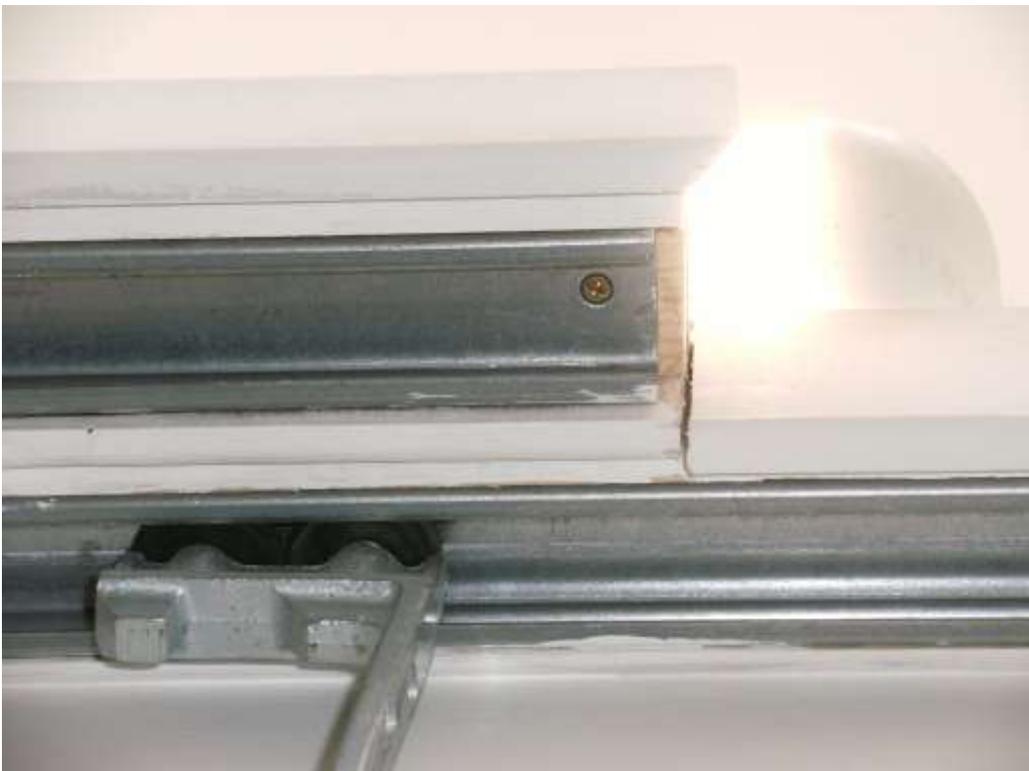
- 7.3. We have been informed that the top rail stopper was never installed and that a bolt or similar was used. We do not have sufficient information to corroborate either claim.

Photograph showing the overlapping top rails and missing stopper.

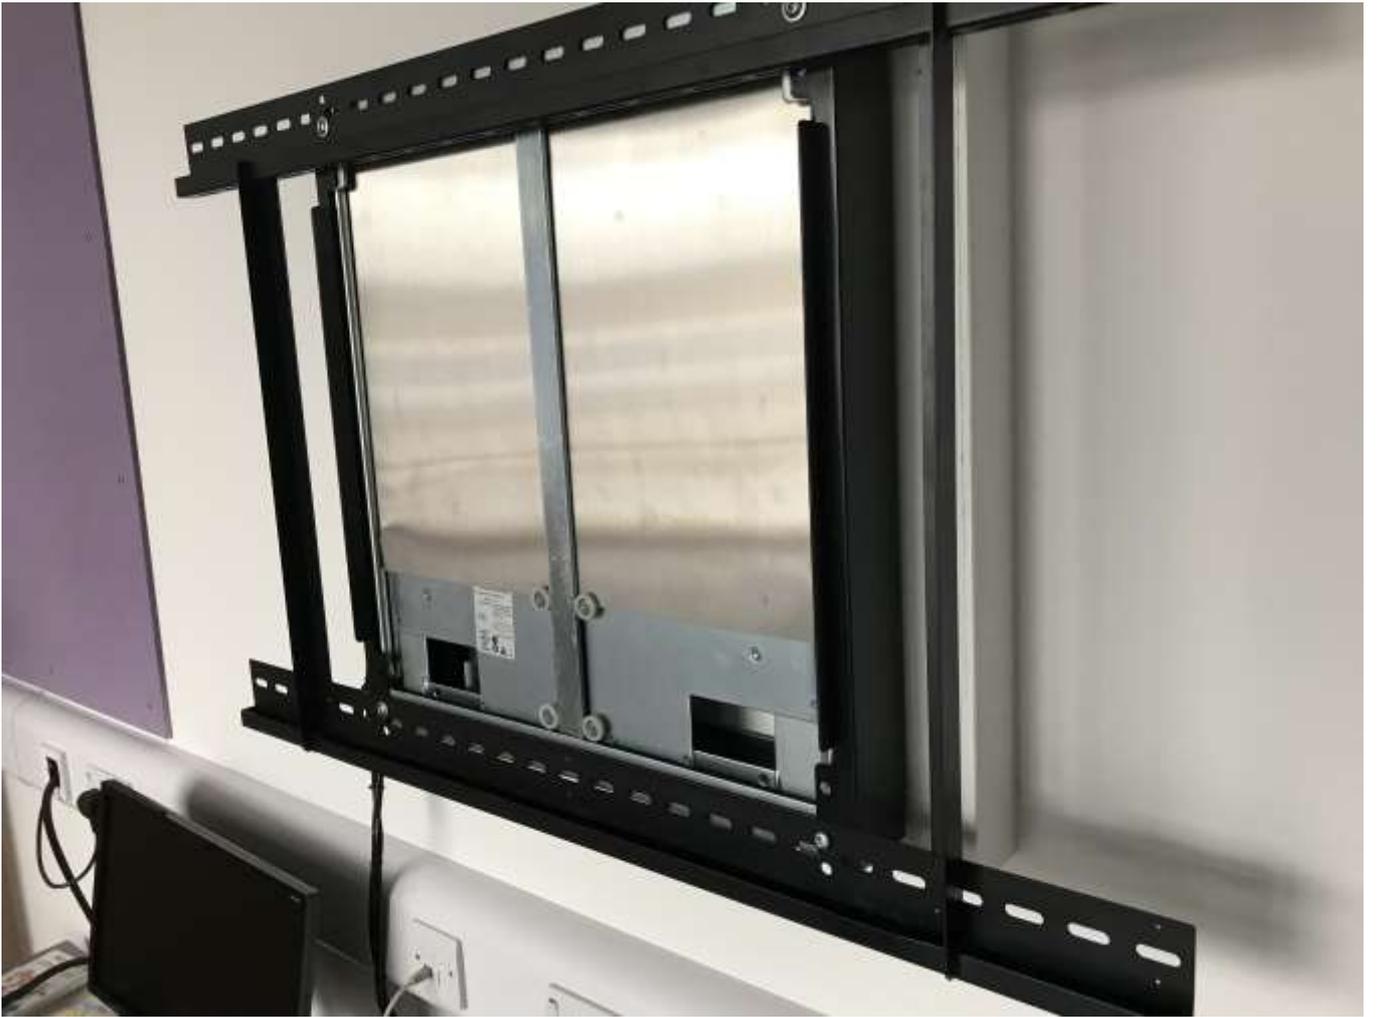
- 8.1. Following granting of Beneficial Access and the NWCC starting to function, a Promethean smart screen on a rise and fall mechanism became loose and struck a 4-year-old child.
- 8.2. Due to the many parties involved, the presence of the end user and other associated groups, there is inevitable contradiction in the first-hand accounts of what happened.
- 8.3. The most common candidate for the failure is the lack of the 'anti-theft' bolts in the frame, although this is contested by the manufacturer and supplier. The supplier and installer was AVMI, whose report suggests that the frame had been tampered with following installation. Other statements suggest that there was a lack of training of staff, or that a child should not have been allowed to operate the rise and fall mechanism.
- 8.4. Due to the lack of corroboration around the Point of Cause we cannot determine the root cause.

Photograph showing the Promethean Screen bracket after the screen has fallen.
